## DEFENCE RESEARCH BOARD

#### MOBILITY RESEARCH ON SMALL HIGH-MOBILITY VEHICLES

Organic and Associated Terrain Research Unit  
McMaster University  
Hamilton, Ontario

Report No. DR 167

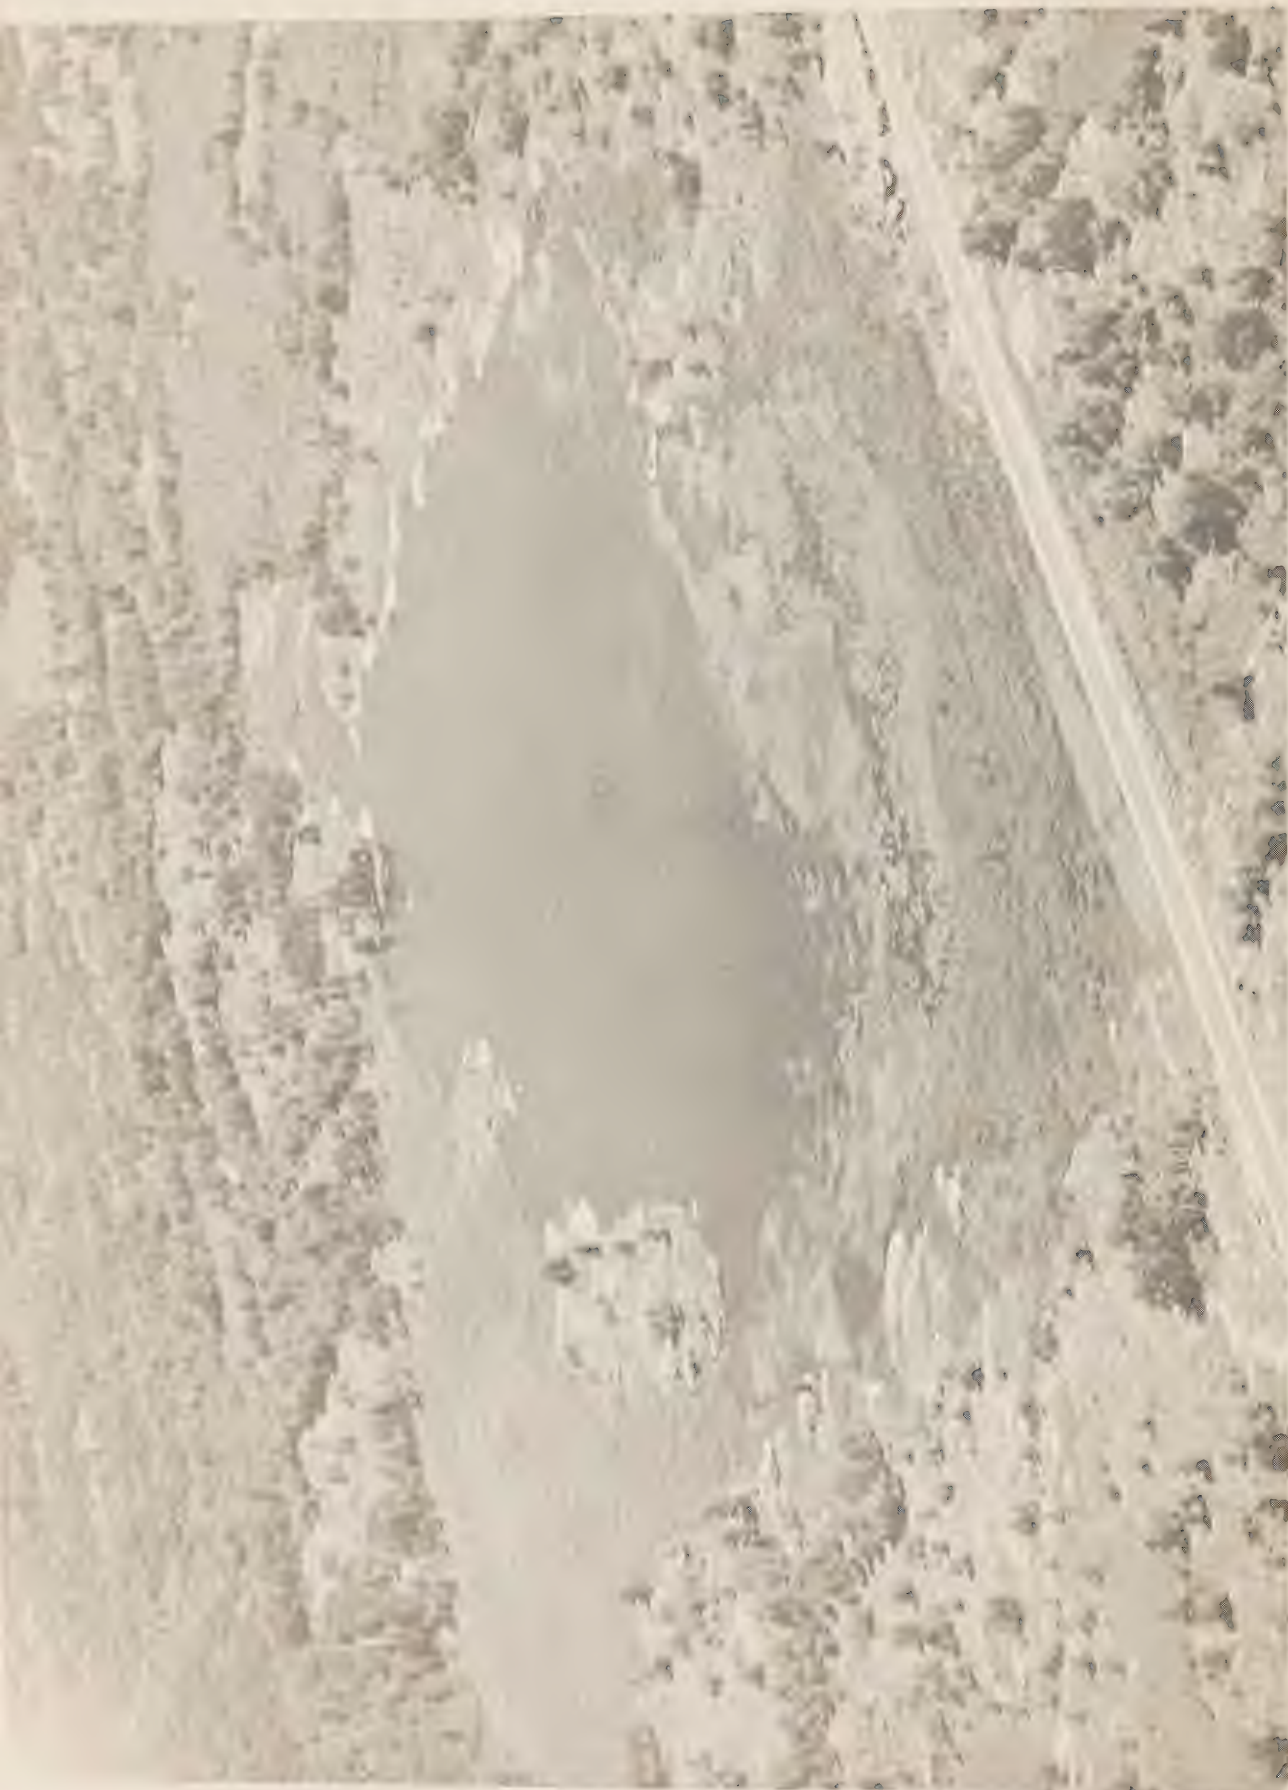
Appendix 2. Aerial Photo of Dinner Lake Trials Area

The maps and photographs in Appendix 2 contain information on routes, test sites, terrain types, vehicle hazards and obstacles, route deviations, and route profile.

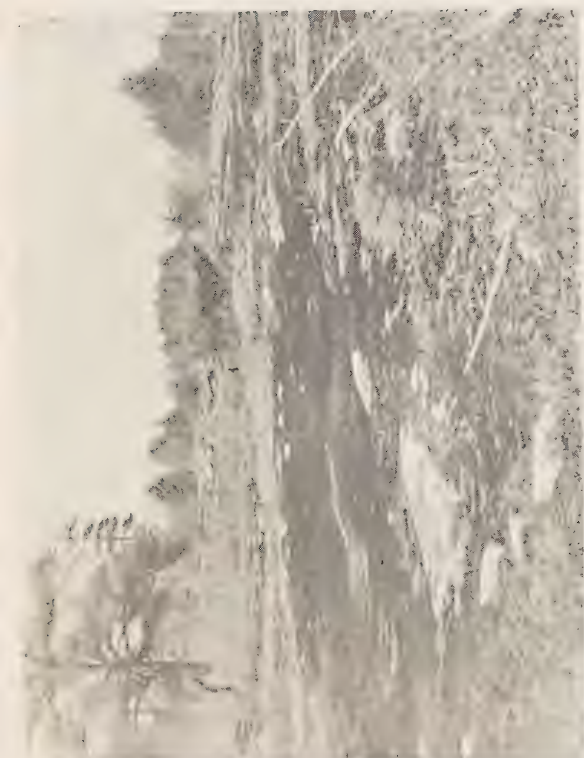
- Fig. 12. EI cover — mounds
- Fig. 13. Pre-Cambrian terrain
- Fig. 14. Mixed muskeg and mineral terrain
- Fig. 15. Plant material in tracks of RAT
- Fig. 16. Vehicle A in FEI

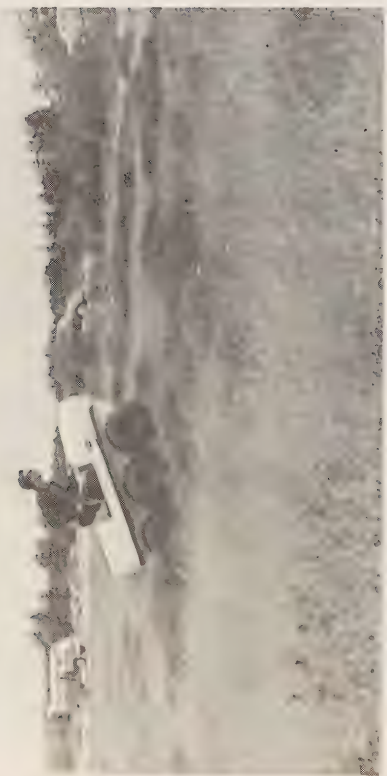
- Fig. 23. Vehicle A — water trials
- Fig. 24. Vehicle B — water trials
- Fig. 25. Beaver channel
- Fig. 26. Vehicle A climbing obstacle
- Fig. 27. Vehicle B failing to climb obstacle

Figs. 23 and 24 show these tests.

In Fig. 24, Vehicle B has the new transmission installed.

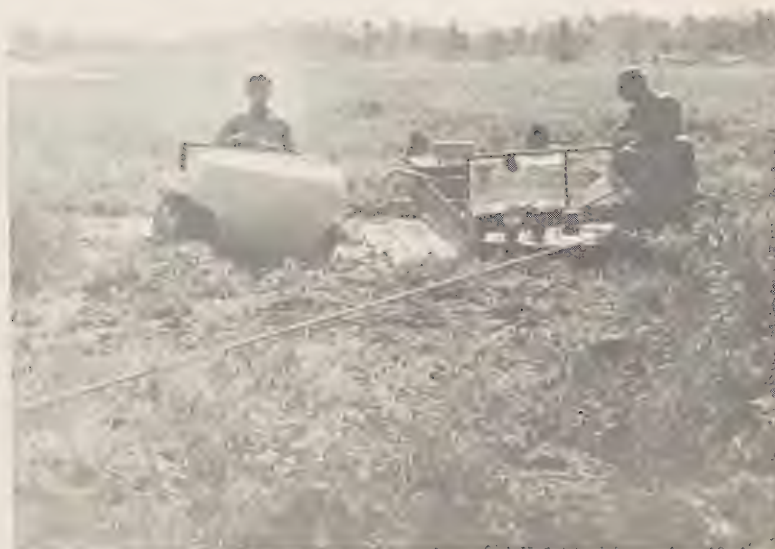
*Fig. 38.*

- Fig. 38. M29C (Weasel) immobilized

One important conclusion from these tests is that both vehicles are able to remain mobile and move effectively in any kind of muskeg, insofar as bearing capacity of the terrain is concerned. In this respect these vehicles are unique. For instance, both vehicles can maintain mobility on terrain in which the M29C tracked vehicle bogged down (Fig. 38). The Water Buffalo, the only other vehicle that can negotiate all categories of muskeg, can do so only with the aid of power applied to an anchored cable. Vehicles designed along the lines of those tested will therefore be useful anywhere in Canada where muskeg occurs, provided other aspects of organic terrain such as surface obstruction, or inherent mechanical design characteristics of the vehicles, do not limit the operation. It is emphasized that these two vehicles are the first to give this indication, and show great promise with respect to off-road activities with a light payload.
